Fire & Rescue NSW
Greenacre PFAS Investigation
Preliminary Site Investigation and Sampling & Analysis
Quality Plan

August 2016

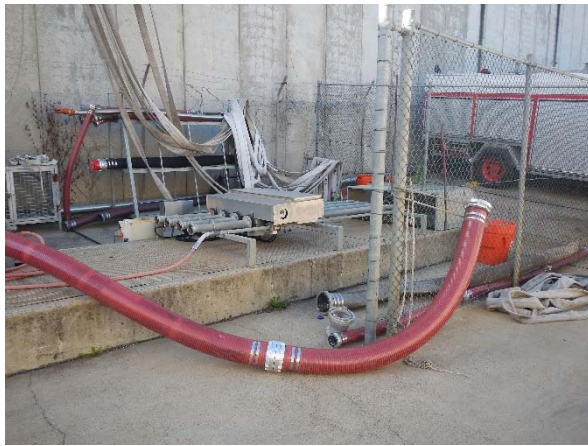
- The main area where AFFF has reportedly been used is around the pump pit (Photograph 1, Plate A) at the eastern boundary of the site. According to the staff at the site, the water in the trucks is recycled through this pump pit. The water is pumped into a holding tank within the pump pit then subsequently pumped back in to the truck after servicing is complete. GHD understands that the foam is not recycled. Trucks park up beside this area and the foam would be released from the foam holding tank of the truck. Best practice was to have a bunded container (IBC) where the foam was decanted and disposed of but this may not have always been the case. GHD were provided with a recommended practice document for the *Replacement of Inlet and Outlet Fittings Recovery and Refill of B Class Foam* which documents the best practice on the recovery and refilling of foam from the trucks.

▲ **Photograph 1:** The pump test area located at the eastern side of the site. AFFF was flushed through the trucks and captured in IBCs. There is a potential for some spills and overflows during this process.

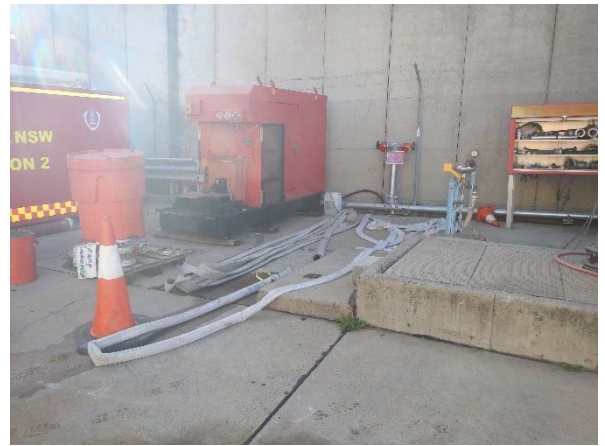
▲ **Photograph 2:** The same as photograph 1 but facing further to the north. The area is all concrete hardstand and the area drains to the west towards subsurface drains.

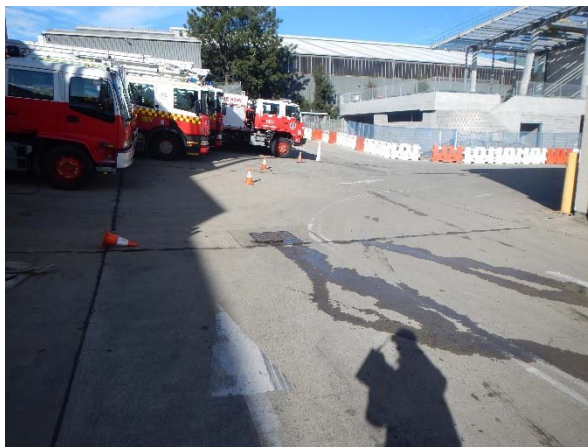
- The area in the south eastern corner of the site was also use to run training courses on fire extinguisher training to the public (Photographs 3, 11 and 12 of Plate A). This usually occurred on trays and the foam was allowed to evaporate and the end product was disposed into trade waste.

▲ **Photograph 3:** Facing south in the eastern end of the site. The area was formerly used as fire extinguisher training to the public. The new administration building is being built in the background.

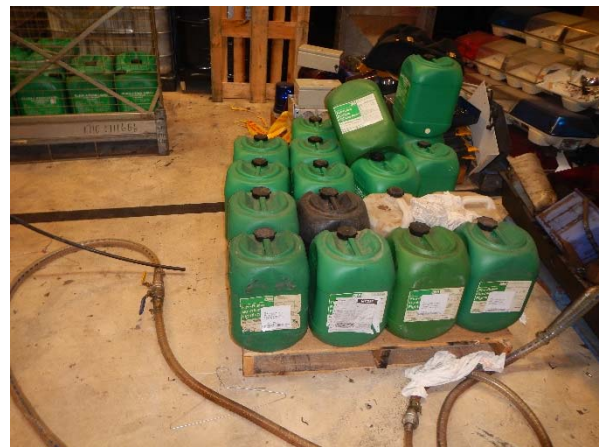
- Greenacre site stores foam in either 20 L container or IBCs for disposal at the north eastern corner of the main warehouse and mechanical workshop. The subcontractor the disposal of the foam and have an inventory of what has been disposed of since 2014. All AFFF for disposal from locations throughout NSW comes to the site for disposal through Solveco (Photographs 4, 5, 6, 7, Plate A shows the AFFF for disposal).

▲ **Photograph 4.** Waste storage for destruction located in the northern building of the site at the western end. This product is fire-brake bushfire fighting foam.

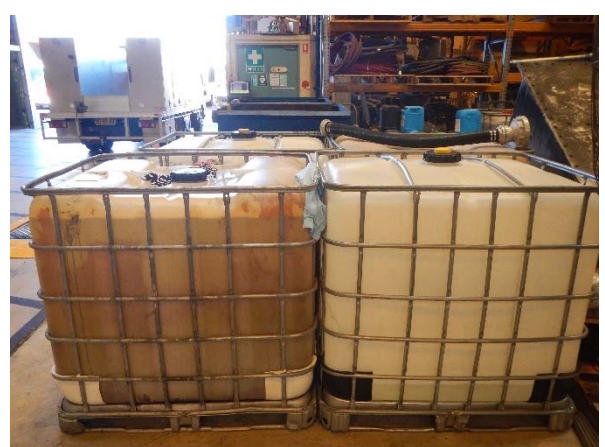
▲ **Photograph 6:** Four IBCs with foam for destruction located at the same area.

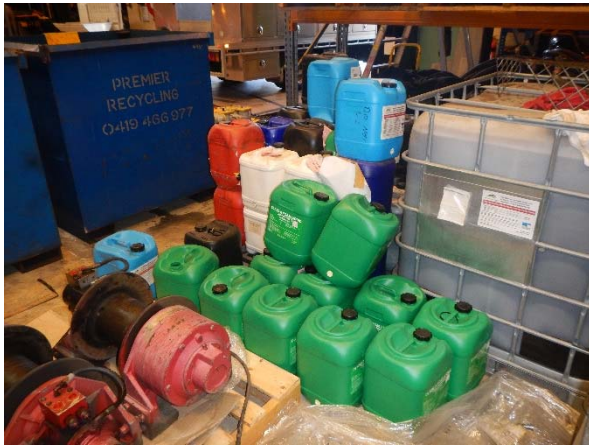
▲ **Photograph 7:** More drums for destruction located at the same area.

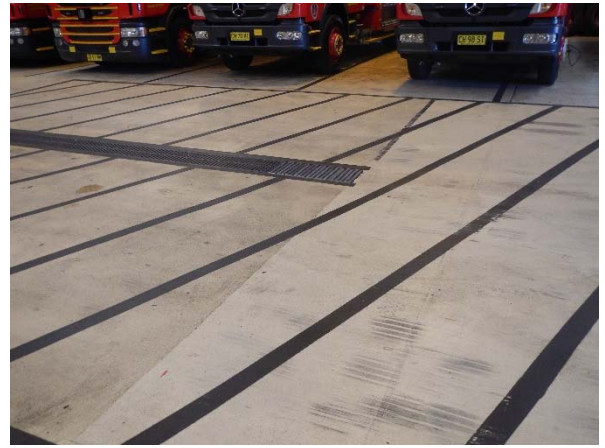
- No ponded surface water was noted on site. The site is highest in elevation at the entrance to the site at Amarina Avenue. The site slopes towards the north eastern boundary with some low points in the middle of the site. The majority of the drains onsite lead to the onsite interceptor and other drains to stormwater which leaves the site in the north eastern corner. (Photographs 8, 13 and 14, Plate A)

▲ **Photograph 8:** The building located in the north of the site that is used for mechanical maintenance and machine fit out with one internal drain located in the middle of the road..

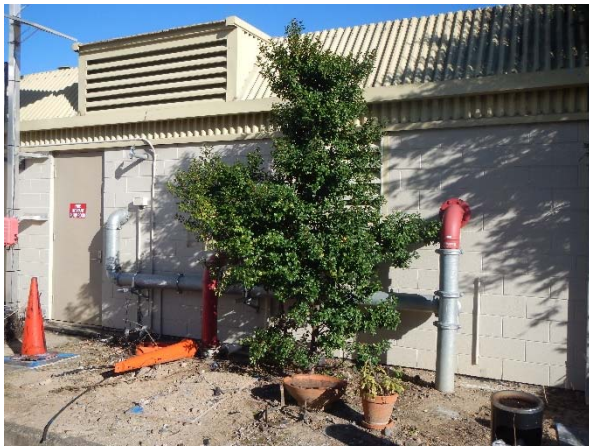
▲ **Photograph 9:** Generator for the site in the western area of the site.

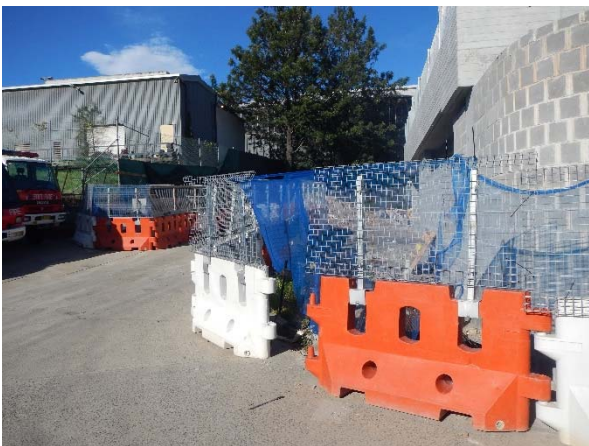
▲ **Photograph 11:** Facing south where the former fire extinguisher training was conducted.

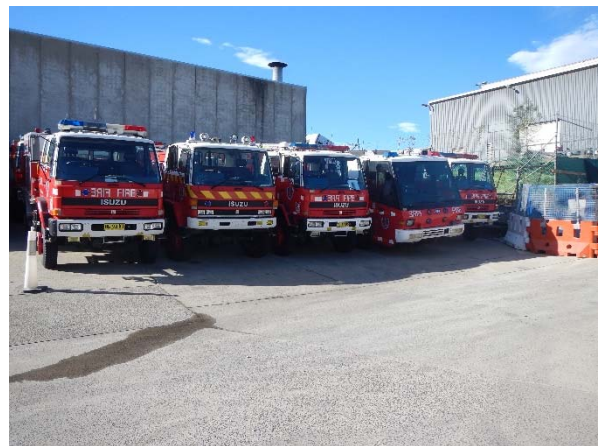
▲ **Photograph 12:** Facing south east where the former fire extinguisher training was conducted..

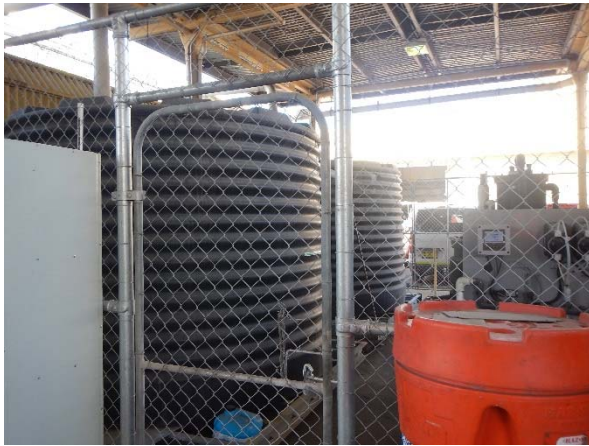
▲ **Photograph 13:** The interceptor and rain tanks located near the truck wash in the eastern area of the site.

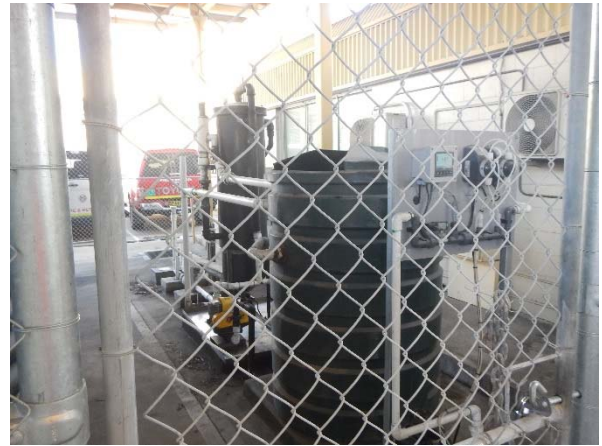
▲ **Photograph 14:** The interceptor for the site where the internal drains go to.

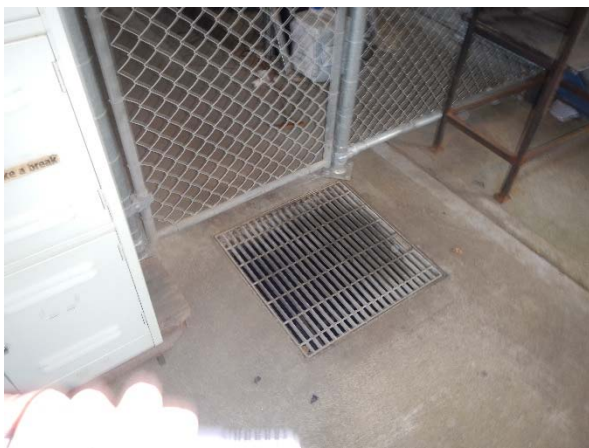
▲ **Photograph 15:** A drain outside the interceptor cage. Unsure if this is attached to the interceptor or stormwater for the site.

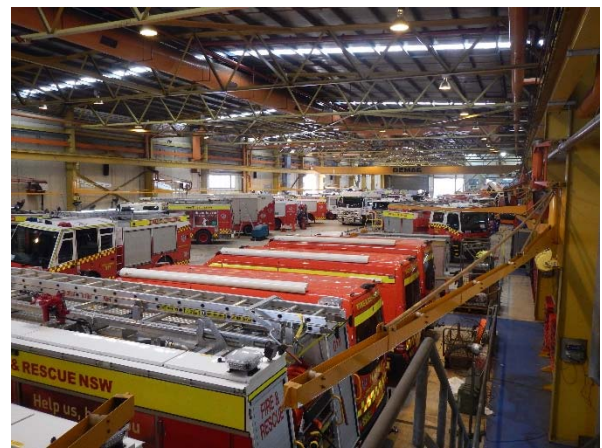
▲ **Photograph 16:** Inside the northern building where truck fit outs, maintenance and the waste storage is held..

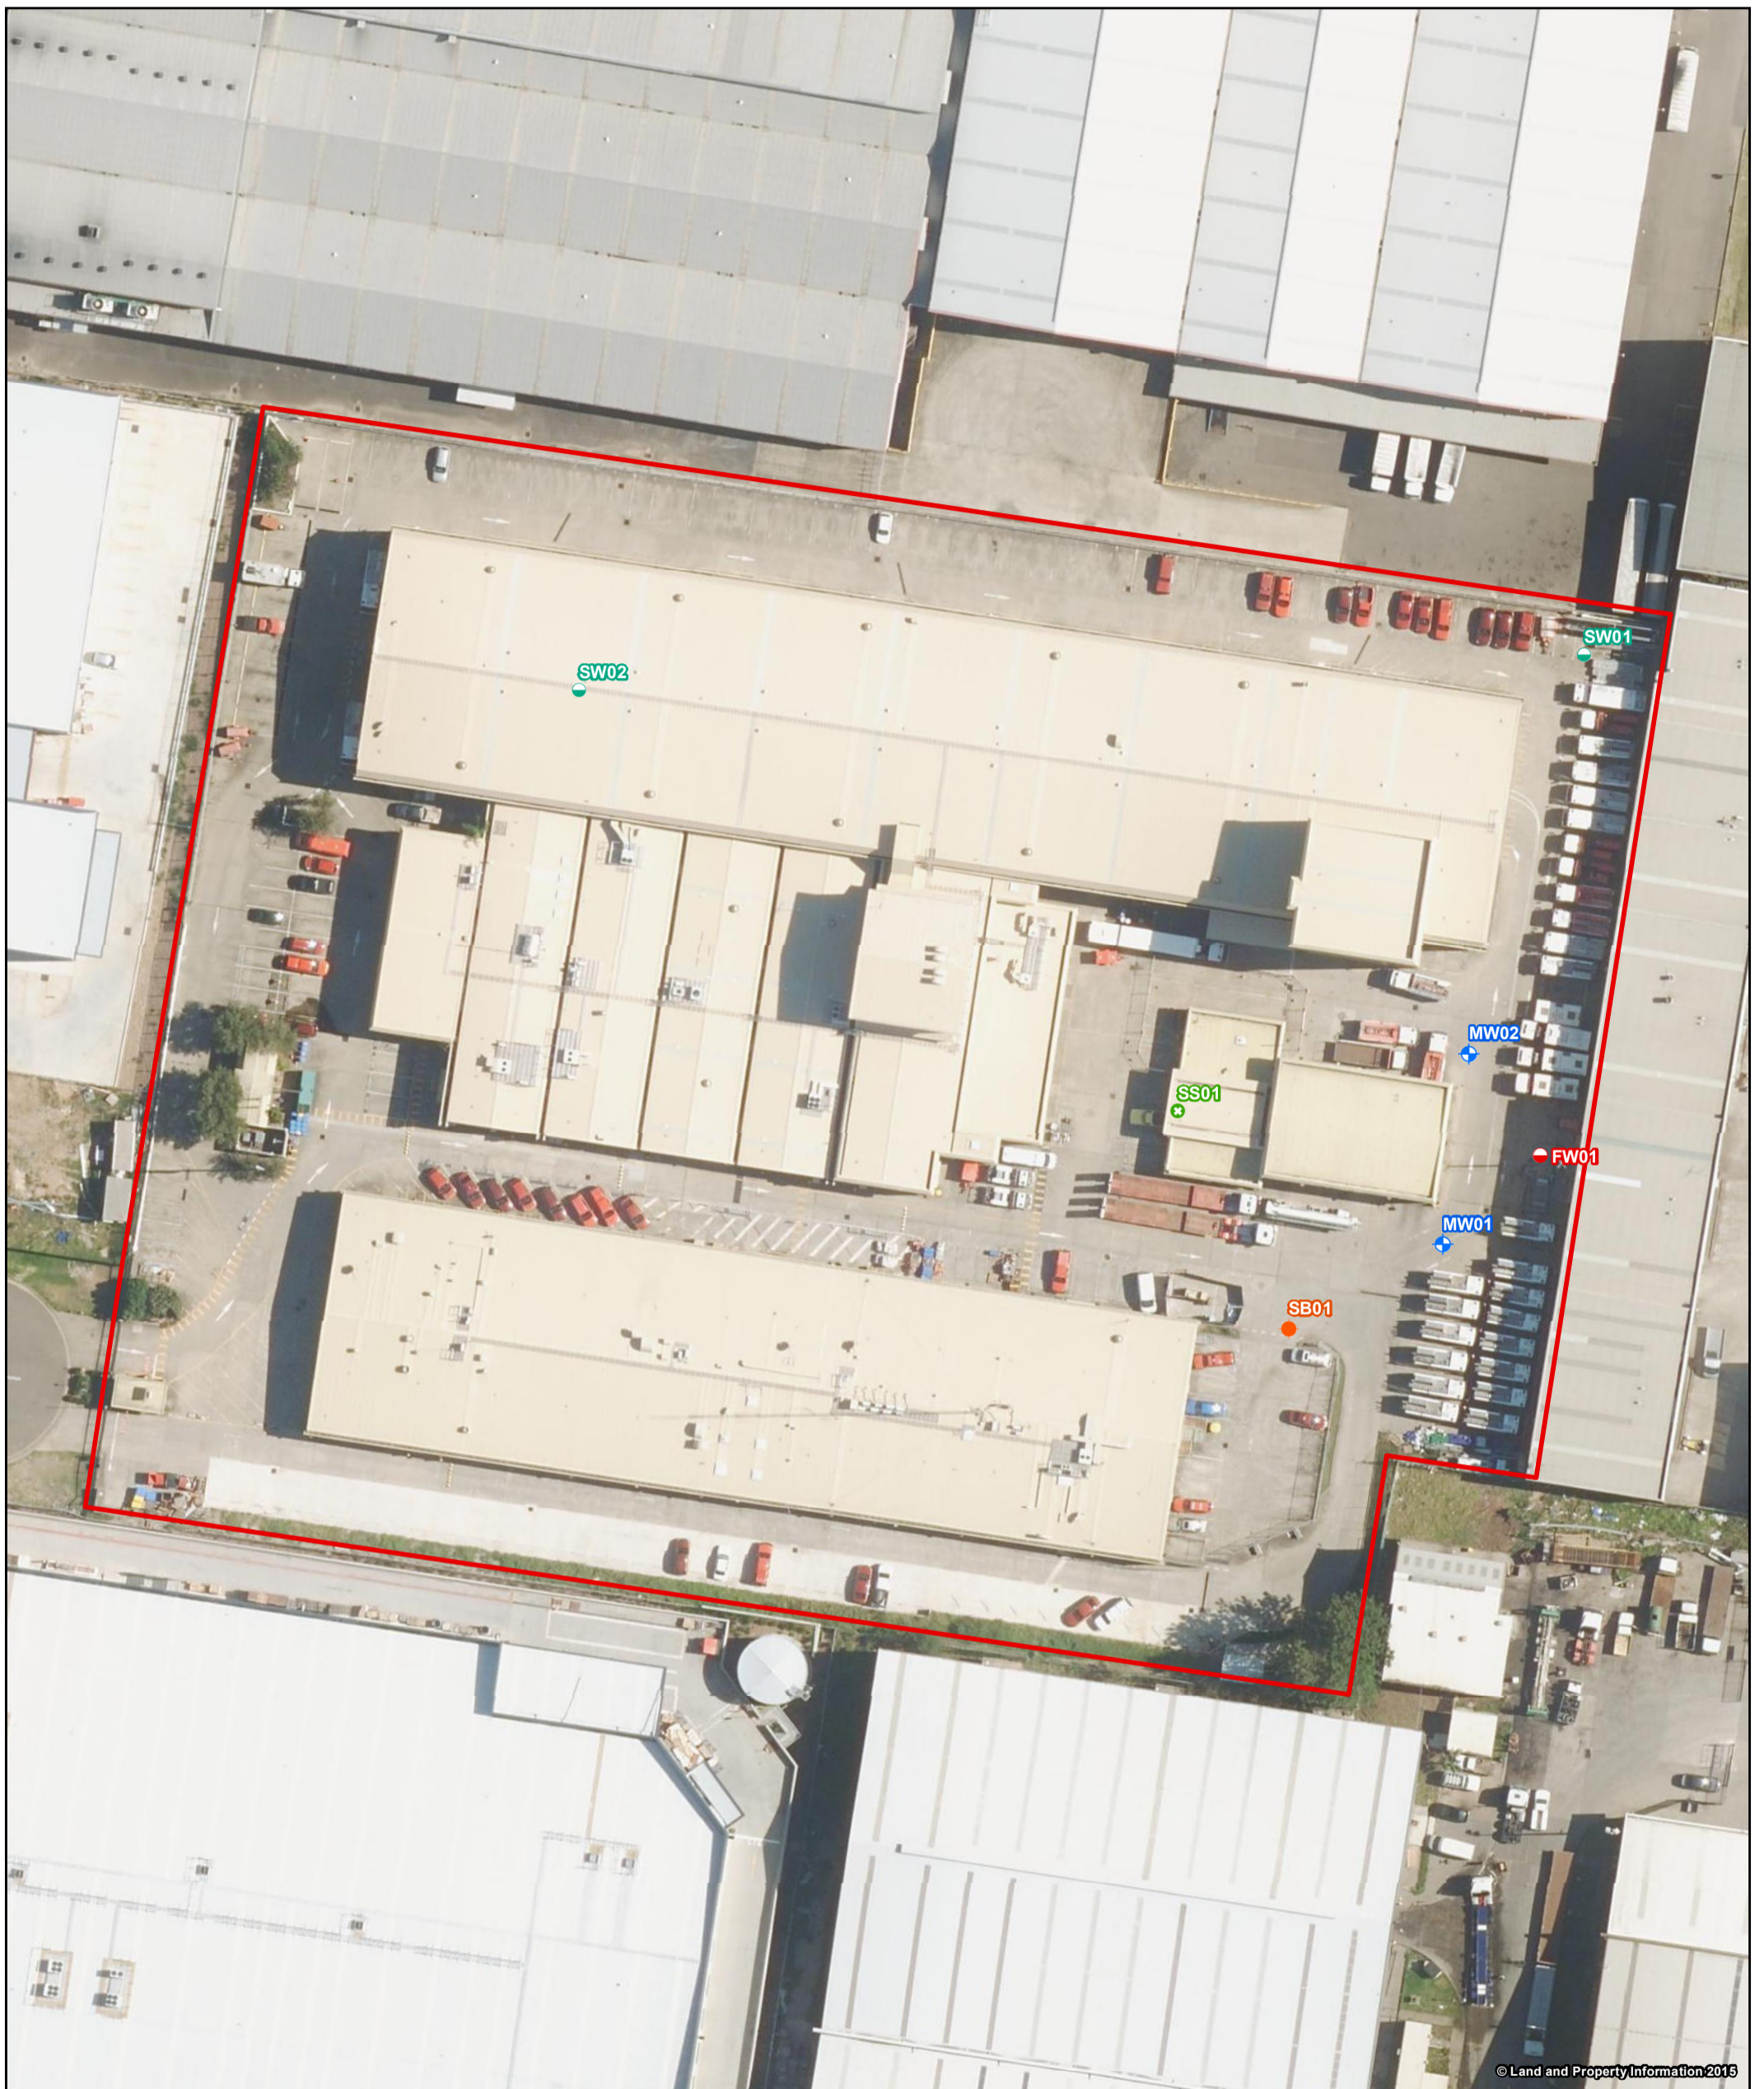
- LEGEND**
- Site Boundary
 - Streets
 - Major Waterways
 - Minor Waterways
 - + Proposed Monitoring Well (2)
 - Proposed Soil Bore (1)
 - ⊕ Proposed Sediment Sample (1)
 - Proposed Surface Water Sample (2)
 - ⊖ Proposed Recycled Fire Water Sample (1)
