Fire research report

Residential Sprinkler Research

Document ID: D17/8418

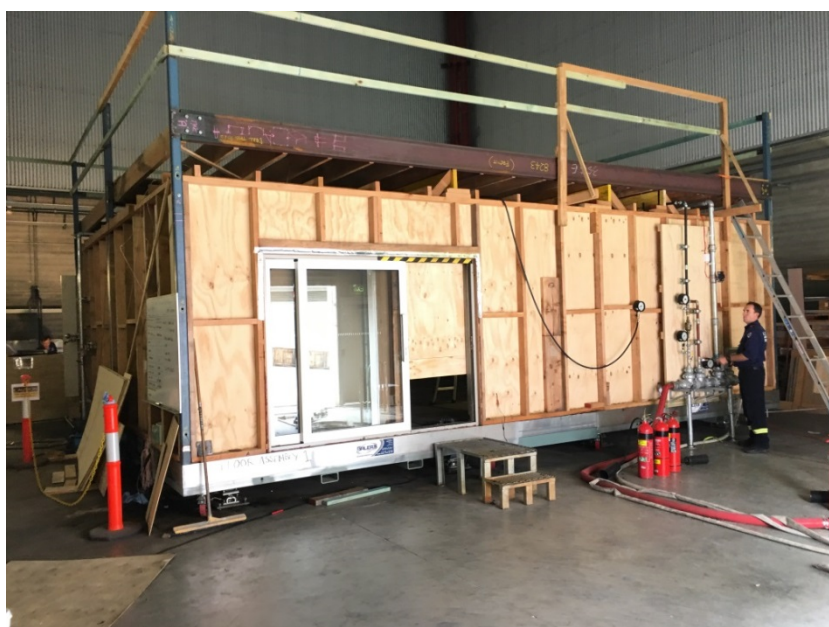
Figure 1 View of the floor assembly

The re-burnable test structure was designed and built by FRNSW in consultation with the CSIRO and Galea's Engineering. The rig consists of a series of four moveable floor modules measuring 3.6 metres by 3.6 metres wide, with the floor surface sitting approximately 400 millimetres off the ground. Two centre expansion modules measure 3.6 metres by 1.2 metres wide to create a floor assembly area of 7.2 metres by 8.4 metres, or 60.48 square metres. The floor modules consist of a steel rectangular hollow section (RHS) sub-frame set on four heavy-duty caster wheels to allow for manoeuvrability. On top of the RHS sub-frame sits three layers of differing materials starting with 16 mm particle board, followed by 16 mm fire-resistant gypsum board and then a layer of 16 mm fibre-cement sheeting. The layers provide stability and protection of the sub-floor equipment from fire.

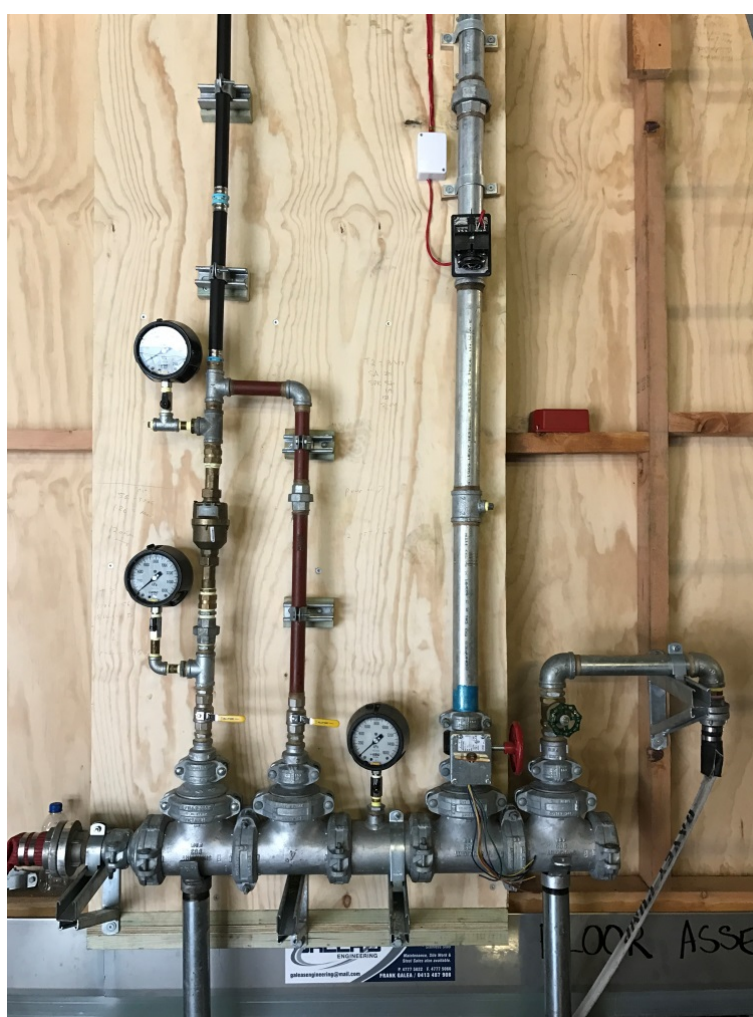
Figure 4 Photo showing the two sprinkler systems. To the left is the 25 mm polyethylene piping of System 1 (Domestic), and to the right is the 50 mm steel piping of System 2 (Hydrant).

Two sprinkler systems were used during the testing: one is a modified Domestic system based on AS 2118.5 (Part 5) (Standards Australia, 2008a) and the other is a residential (Hydrant serviced) system based on modified AS 2118.4 (Part 4) (Standards Australia, 2012) system. The sprinkler heads used for both systems were identical, and were a rapid response, domed-plate concealed, pendant-type sprinkler head with a discharge coefficient (K-factor) of 4.9. The temperature rating for the cover plate is 59°C and for the sprinkler bulb is 68°C (see Appendix B). There were eight sprinkler heads installed for the Domestic, Part 5 system (designated 'D') in locations as detailed in Figure 3, and nine for the Hydrant, Part 4 system (designated 'H').

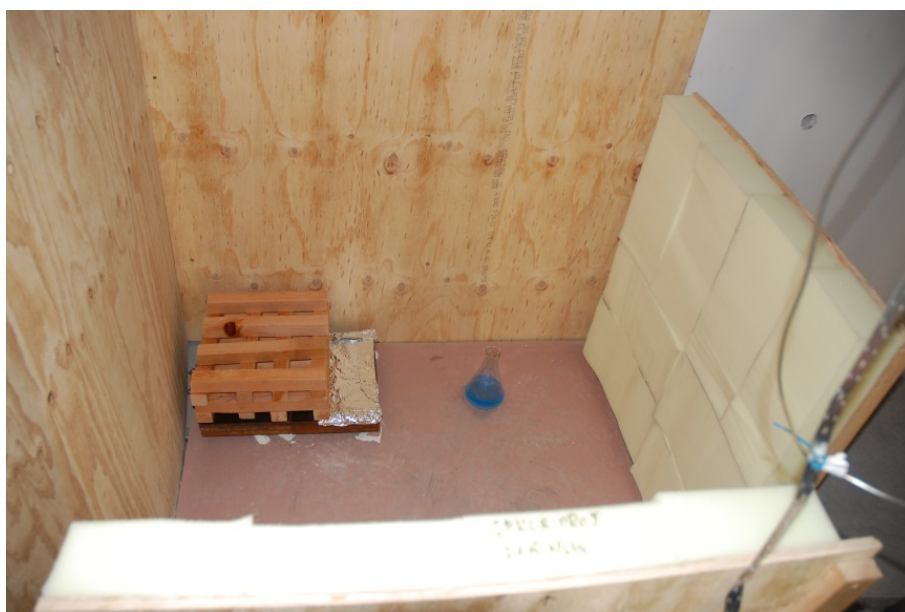
Figure 5 View of the ignition point and surrounding props in Test 1

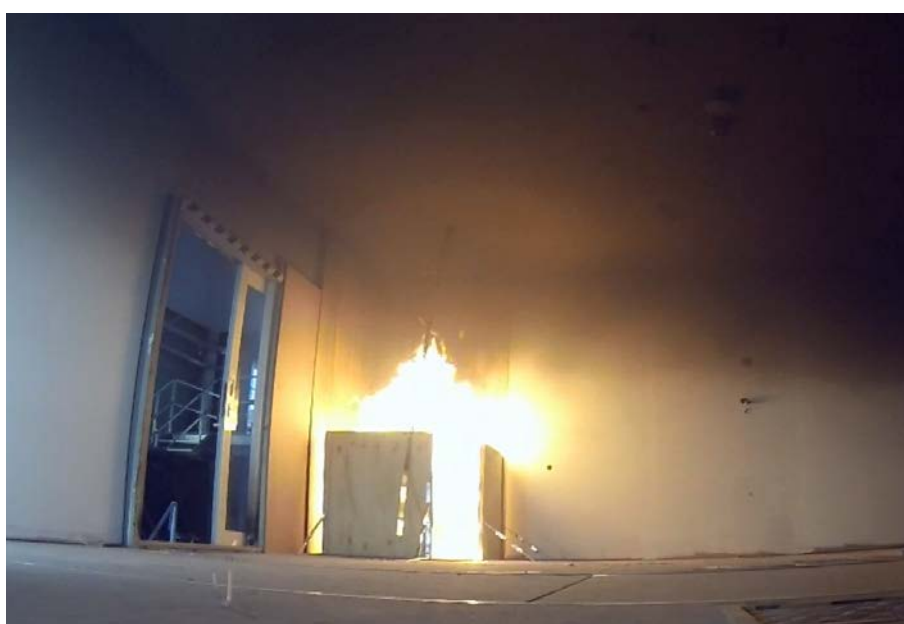
Figure 7 View of the test fire before sprinkler activation

In Test 1, the peak flame height was approximately 2 metres (Figure 7). The foam pads surrounding the ignition crib were fully consumed during the test; however, the crib itself and the plywood surrounds remained intact (Figure 8).

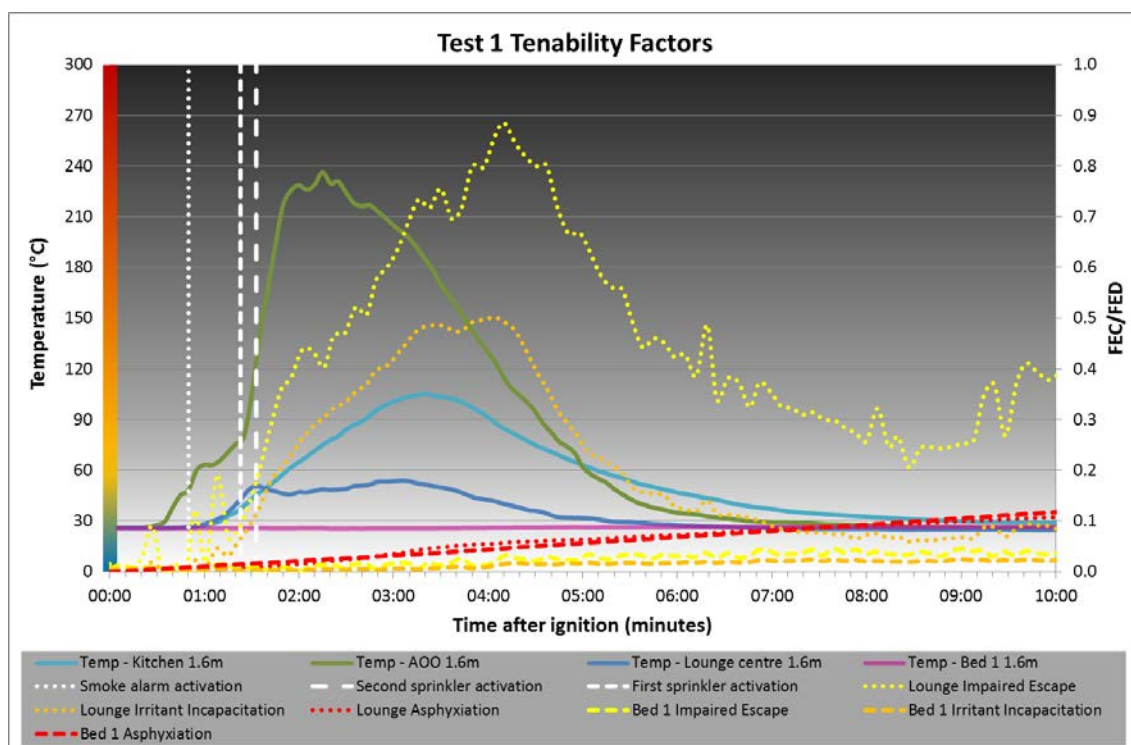
Figure 10 Chart showing timing of activations and tenability factors for Test 1

At the Lounge centre, gas sampling at 1.6 m (G2) found that irritant concentrations rose to a level that would cause impaired escape for vulnerable persons (FEC_{esc} 0.3) at 1 min 42 s, peaking at 0.89 at 4 min 10 s after ignition, and remaining mostly above 0.3 for the duration of the test. Conditions in the Lounge would have caused vulnerable persons to become incapacitated due to the irritant concentrations (FEC_{inc} >0.3) for the time between 2 min 16 s

In Bedroom 1, FEC_{esc} , FEC_{inc} and FED_{asp} , peaked at fractional values of 0.07, 0.03 and 0 respectively.

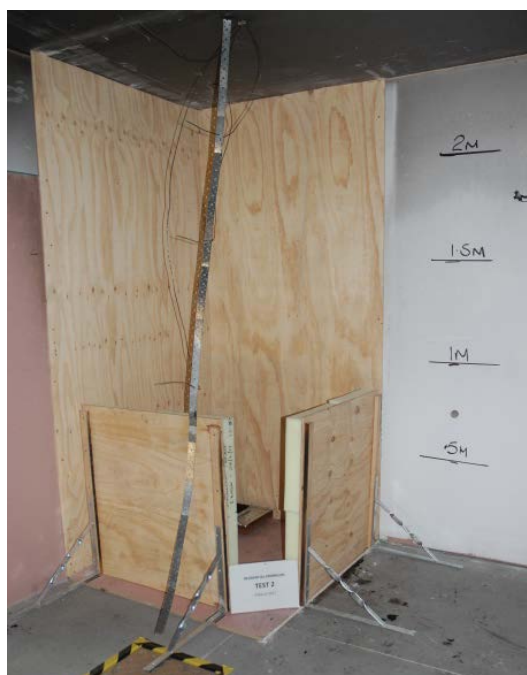
Figure 11 View of the test arrangement for Test 2

The pressure at the meter was set at 700 kPa, the minimum pressure required in the Standard. With the sprinkler system set up, there were seven charged sprinkler heads in operation with this test: H1, which was specifically located to be in accordance with the sprinkler distance with the UL test; and H3, H4, H5, H6, H7, and H8.

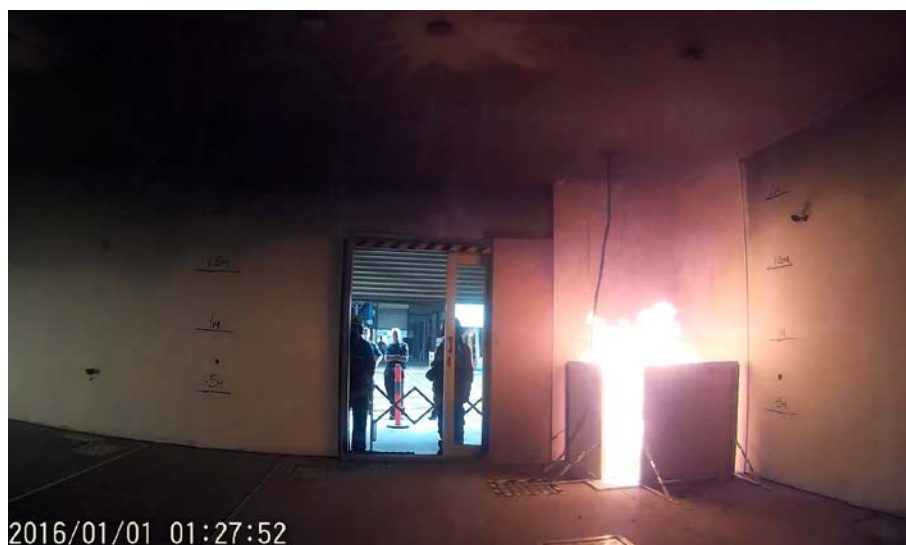
Figure 13 View of the test fire before sprinkler activation

There were two sprinkler activations during this test. H1 in the Lounge centre activated at 1 min 20 s and H4 in the Kitchen activated at 1 min 21 s after ignition. The peak temperatures reached at the sprinkler heads upon activation were 93.3°C and 98.2°C for H1 and H4, respectively. Note the 10 second delay in temperature drop after the H4 activation. Interestingly, the cover for the sprinkler head in the Lounge annexe (H5) dropped at 1 min 25 s at a temperature of 80.1°C; however, this sprinkler head did not activate during the test.

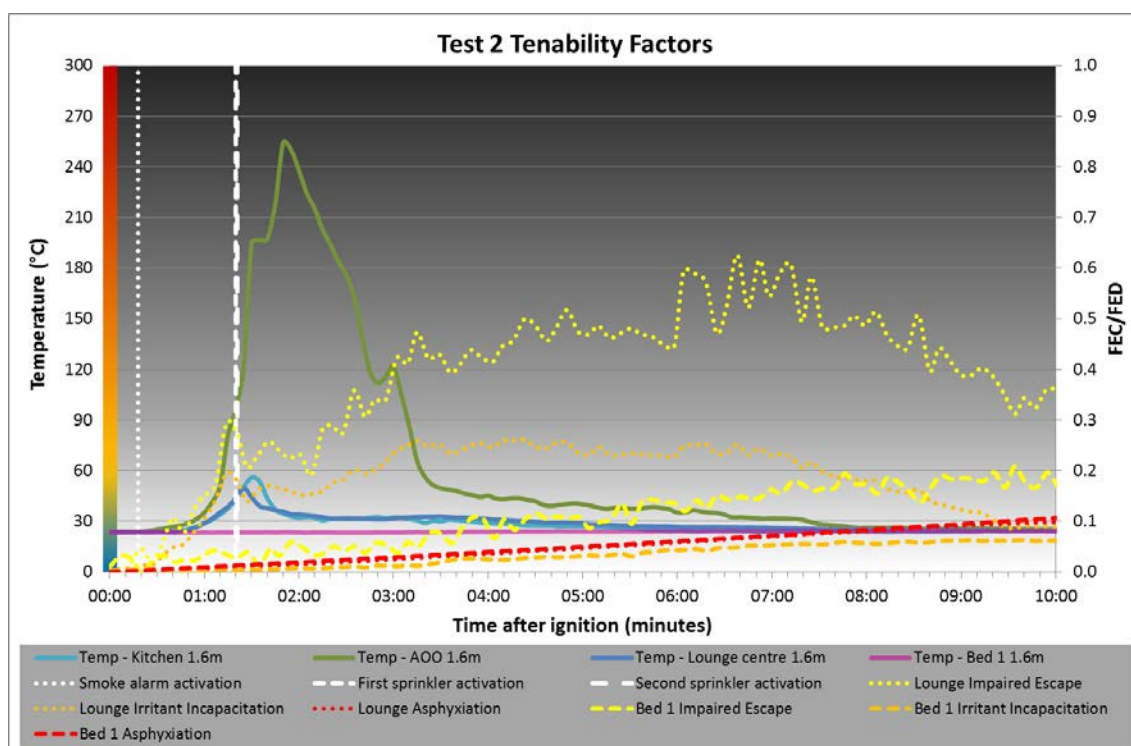
Figure 16 Chart showing timing of activations and tenability factors for Test 2

In Bedroom 1, FEC_{esc} , FEC_{inc} , and FED_{asp} were not reached during the test, with the fractional values peaking at 0.22, 0.06, and 0, respectively.

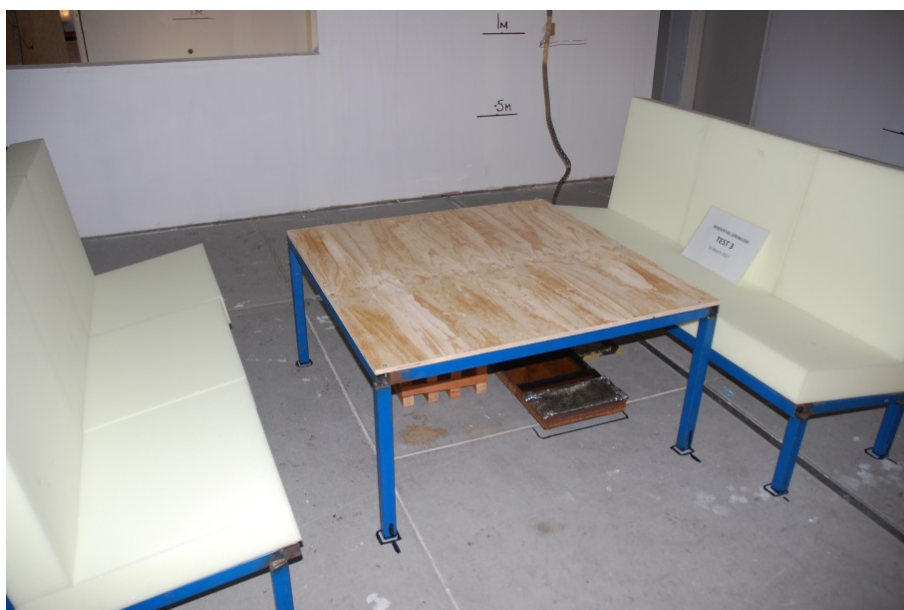
Figure 17 Photo showing the test arrangement for Test 3

In this test, the ignition crib was located in the centre of the Lounge room, underneath a stylised coffee table. The coffee table was surrounded by two stylised sofas. The arrangement is pictured in Figure 17 and detailed in Figure 18. In this test, the external doors were open and the internal doors were closed. The fuel under the crib was a 1:2 mixture of heptane and water. There were seven sprinkler heads in operation in this test: D2, D3, D4, D5, D6, D7, and D8. The pressure at the meter was set at 250 kPa. All other sprinkler heads were made inoperable.

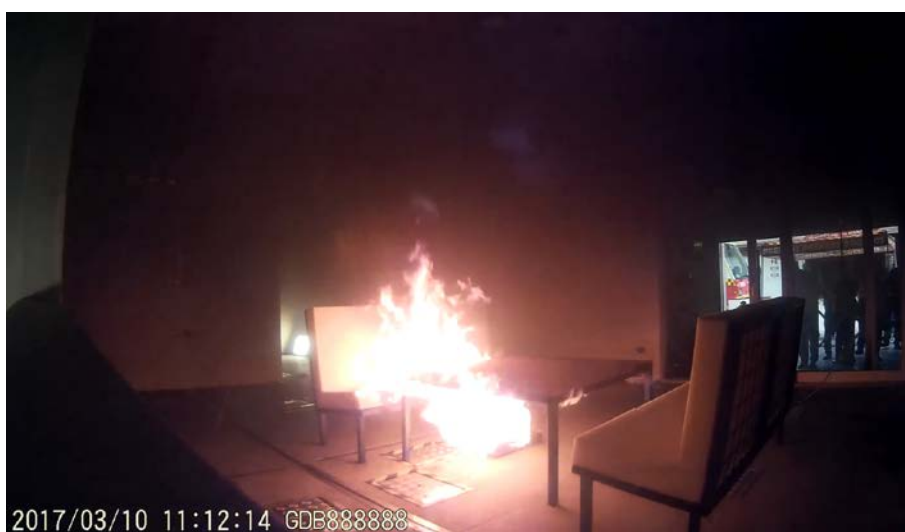
Figure 19 View of the test fire before sprinkler activation

In Test 3, the peak flame height was approximately 1.5 metres (Figure 19). The fire spread to the southern Lounge. Of the six foam blocks representing the sofa cushions, the three seat cushions, and approximately half of the three back cushions were consumed (Figure 20).

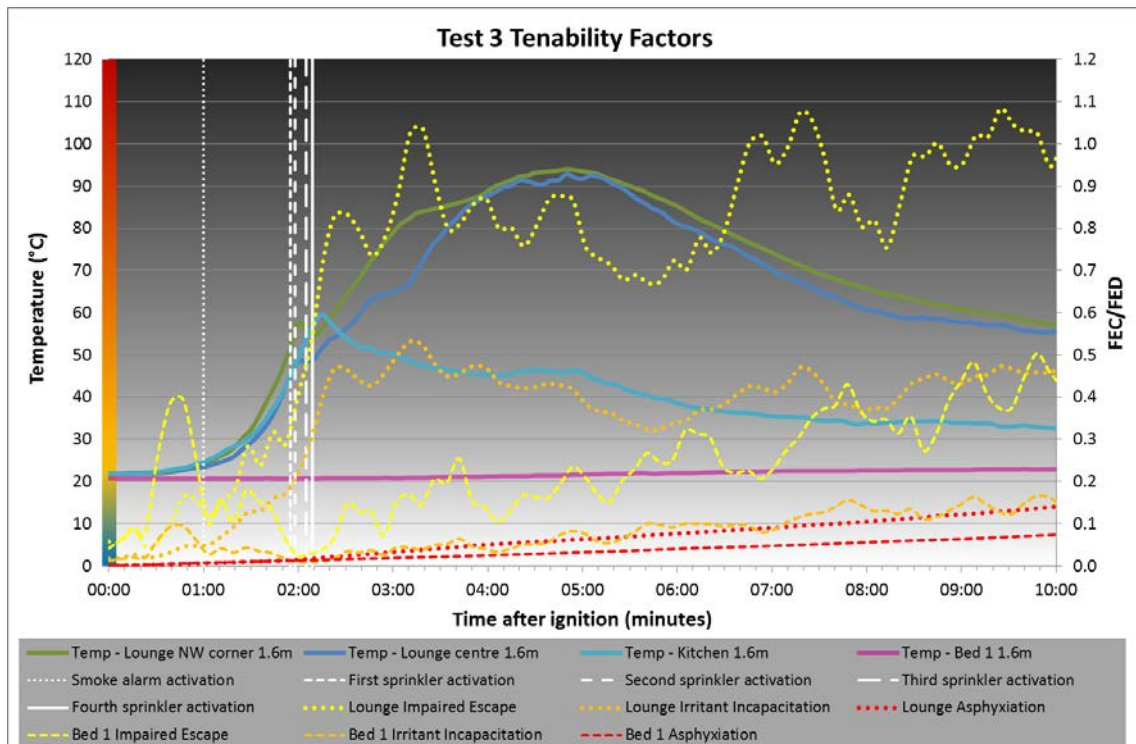
Figure 22 Chart showing timing of activations and tenability factors for Test 3

In Bedroom 1, the threshold for impaired escape due to irritant concentrations ($FEC_{esc} > 0.3$) was reached at 6 min 5 s after ignition. $FEC_{inc} 0.3$ and $FED_{asp} 0.3$ were not reached during the test, with the fractional values peaking at 0.2, and 0.08, respectively.

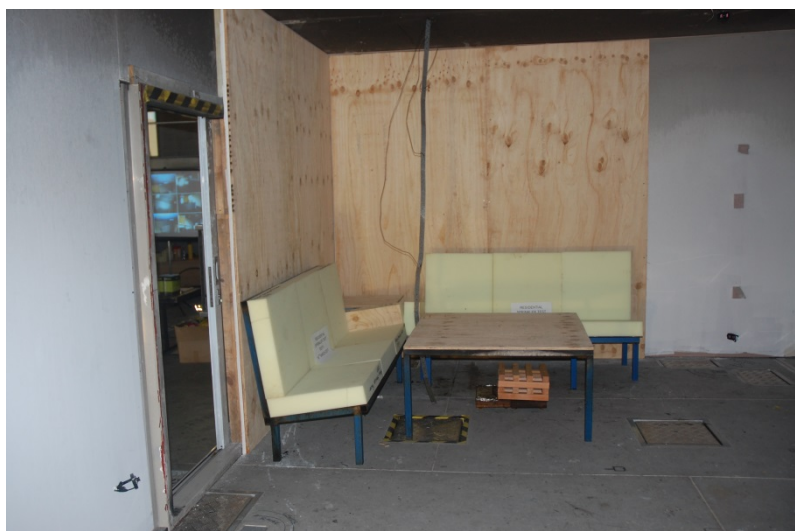
Figure 23 Photo showing the test arrangement for Test 4

In this test, the ignition crib was located in the NW corner of the Lounge room, underneath a stylised coffee table. The coffee table was surrounded by two stylised sofas with a plywood side table placed in the corner between them. The arrangement is pictured in Figure 23 and detailed in Figure 24. In this test, the external doors were open and the internal doors were closed. The fuel under the crib was a 1:2 mixture of heptane and water.

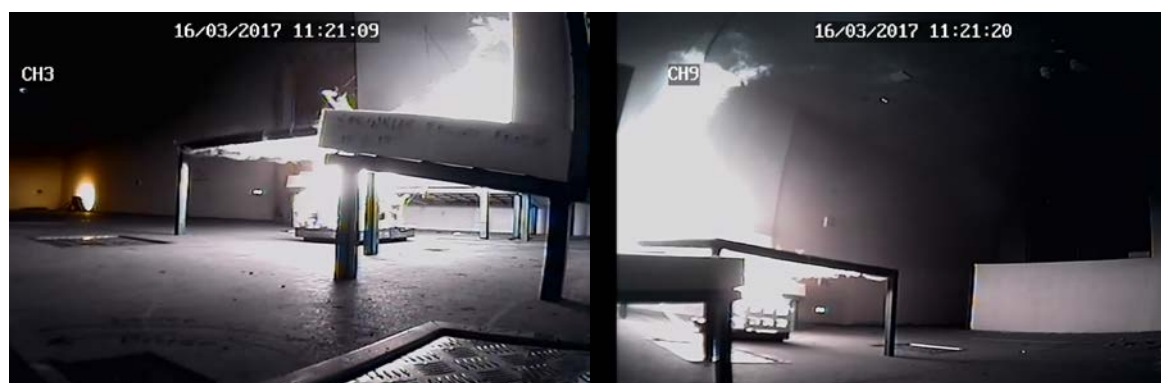
Figure 25 Views of the test fire before sprinkler activation

In Test 4, the peak flame height was approximately 1.5 metres (Figure 25). The fire spread to the northern sofa. Of the seven foam blocks representing the sofa cushions (including arm rest), approximately four blocks were fully consumed with the remaining blocks partially consumed (Figure 26).

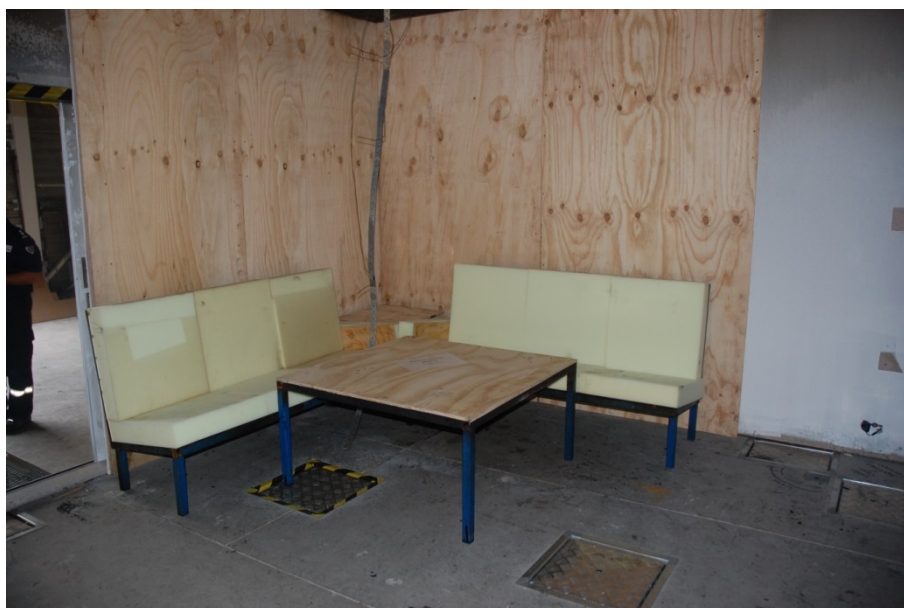
Figure 29 Photo showing the test arrangement for Test 5

In this test, the ignition crib was located in the NW corner of the Lounge room under a stylised plywood side table, which was placed in the corner between two stylised sofas. The arrangement is pictured in Figure 29 and detailed in Figure 30. In this test, the internal and external doors were closed. The fuel under the crib was a 1:2 mixture of heptane and water.

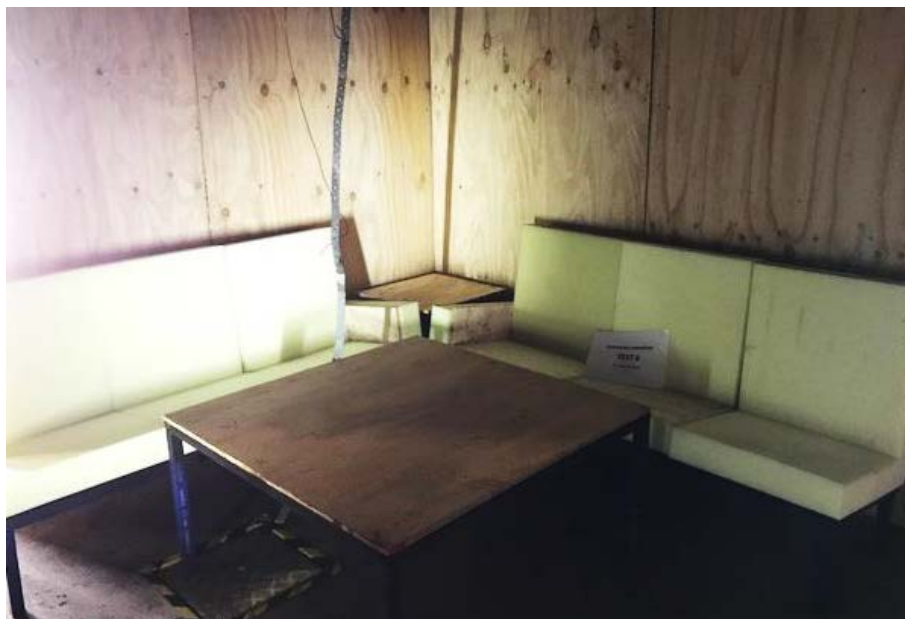
Figure 35 Photo showing the test arrangement for Test 6

The arrangement for this test was identical to that of Test 5. The ignition crib was again located in the NW corner of the Lounge room under a stylised plywood side table, which was placed in the corner between two stylised sofas. The arrangement is pictured in Figure 35 and

detailed in Figure 36. In this test, the internal and external doors were closed. The fuel under the crib was a 1:2 mixture of heptane and water.

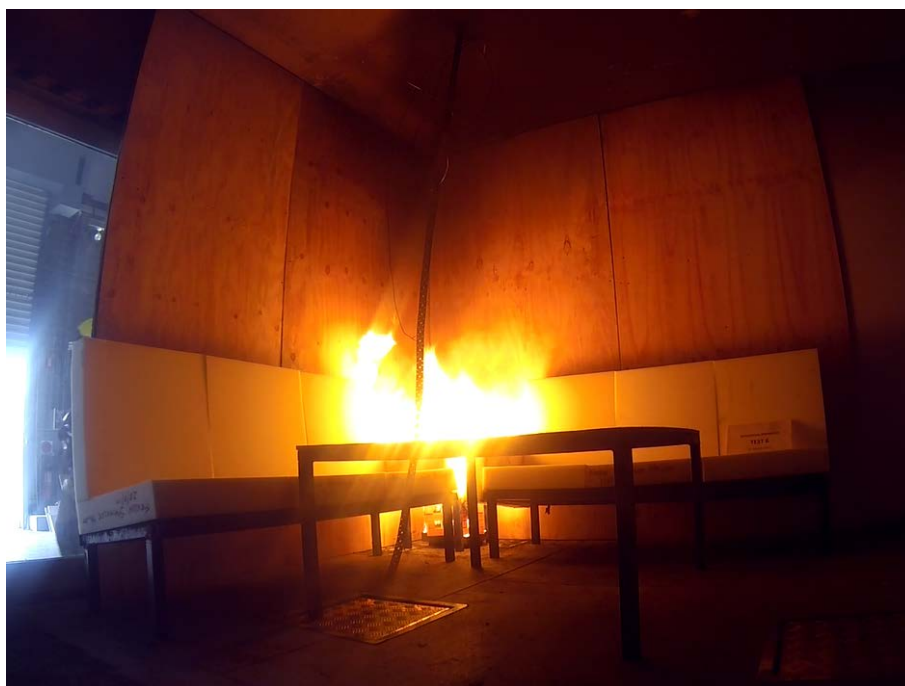
Figure 37 View of the test fire before sprinkler activation during Test 6

In Test 6, the peak flame height was approximately 1 metre (Figure 37). The fire spread to both sofas. The two arm rests were consumed as well as four foam blocks from the northern sofa, and one block from the western sofa (Figure 38).

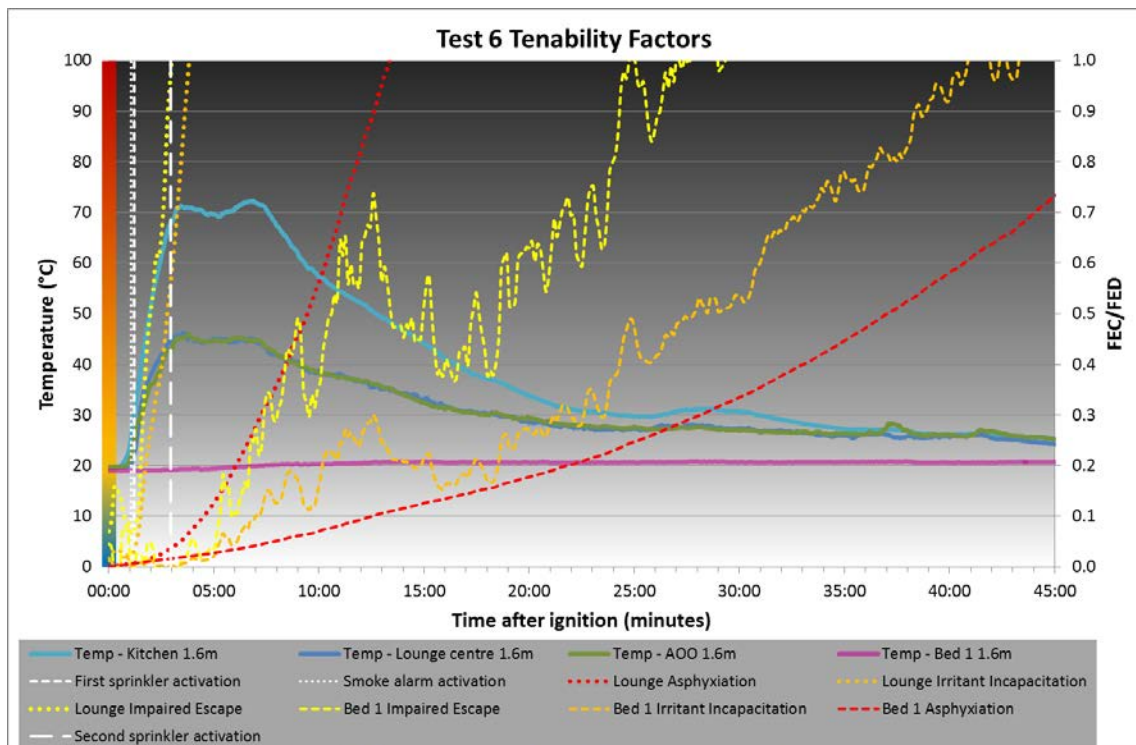
Figure 40 Chart showing timing of activations and tenability factors for Test 6

In Bedroom 1, $FEC_{esc} > 0.3$ was reached at 7 min 25 s and $FEC_{esc} > 1$ was reached at 27 min 1 s. $FEC_{inc} > 0.3$ was reached at 21 min 11 s, with $FEC_{inc} 1$ exceeded after 40 min 56 s. The cumulative asphyxiant gas concentrations rose to $FED_{asp} > 0.3$ in 28 min 05 s, reaching 0.73 by test end.

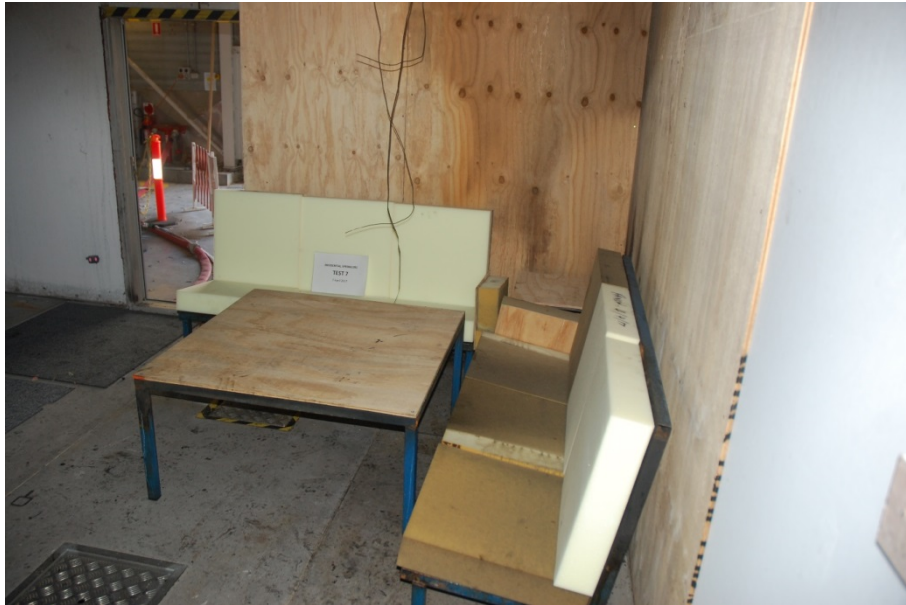
Figure 41 Photo showing the test arrangement for Test 7

The arrangement for this test was identical to that of Test 6, except for the ventilation characteristics. The ignition crib was again located in the NW corner of the Lounge room under a stylised plywood side table, which was placed in the corner between two stylised sofas. The arrangement is pictured in Figure 41 and detailed in Figure 42. In this test, the external doors were closed while the door to Bedroom 1 was open. The fuel under the crib was a 1:2 mixture of heptane and water.

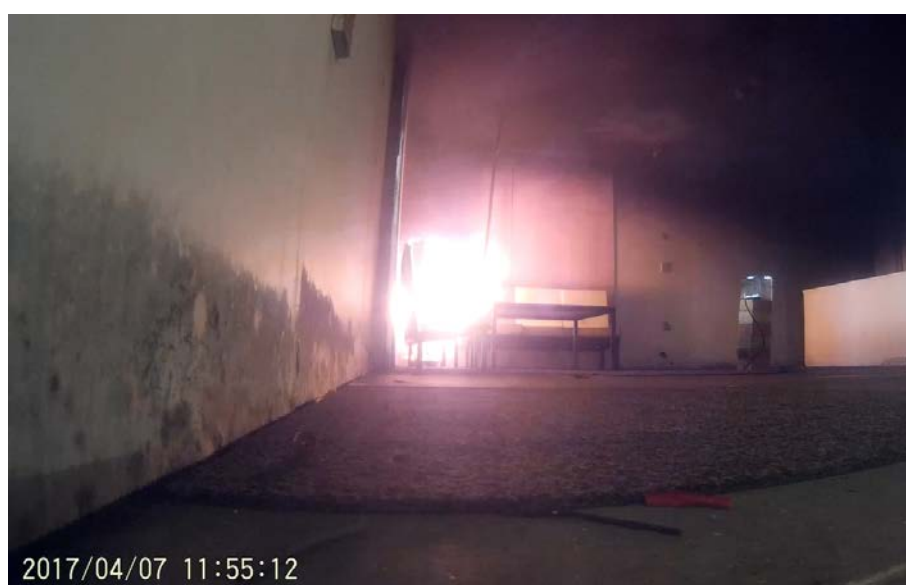
Figure 43 View of the test fire before sprinkler activation

In Test 7, the peak flame height was approximately 1.5 metres (Figure 43). The fire spread to both sofas. The two arm rests were consumed as well as approximately 1.5 foam blocks from each sofa (Figure 44).

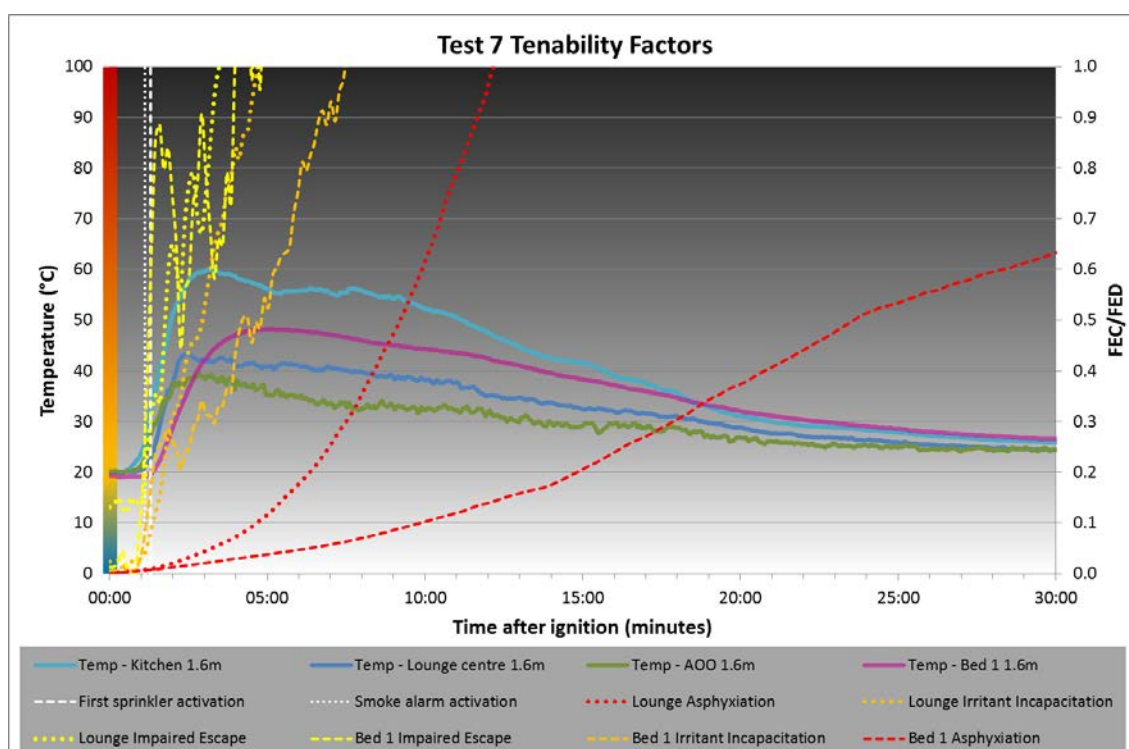
Figure 46 Chart showing timing of activations and tenability factors for Test 7

In Bedroom 1, $FEC_{esc} > 0.3$ was reached at 1 min 20 s and $FEC_{esc} > 1$ was reached at 4 min 6 s. $FEC_{inc} > 0.3$ was reached at 2 min 55 s, with $FEC_{inc} 1$ exceeded after 7 min 33 s. The cumulative asphyxiant gas concentrations rose to $FED_{asp} > 0.3$ in 17 min 45 s, reaching 0.64 by test end.

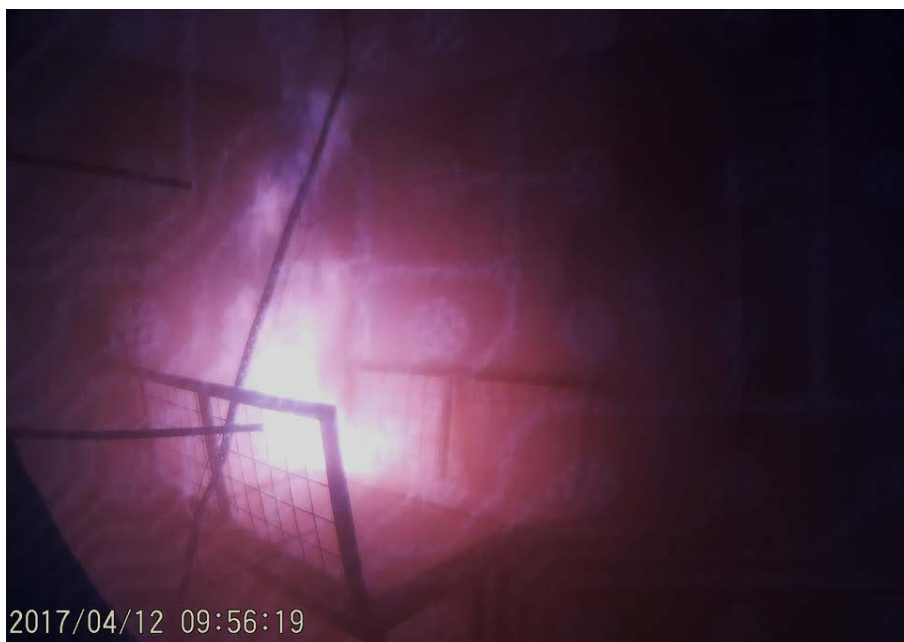
Figure 49 View of the test fire before sprinkler activation

In Test 8, the peak flame height was approximately 2.4 metres or ceiling height (Figure 49). The fire was confined to a single foam block (Figure 50).

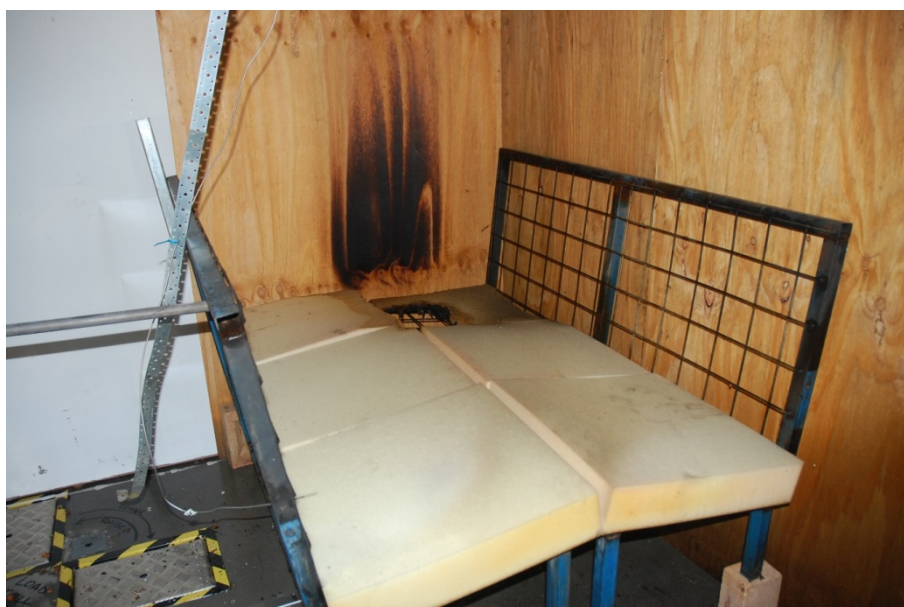
Figure 50 View of the test furnishings at the end of Test 8

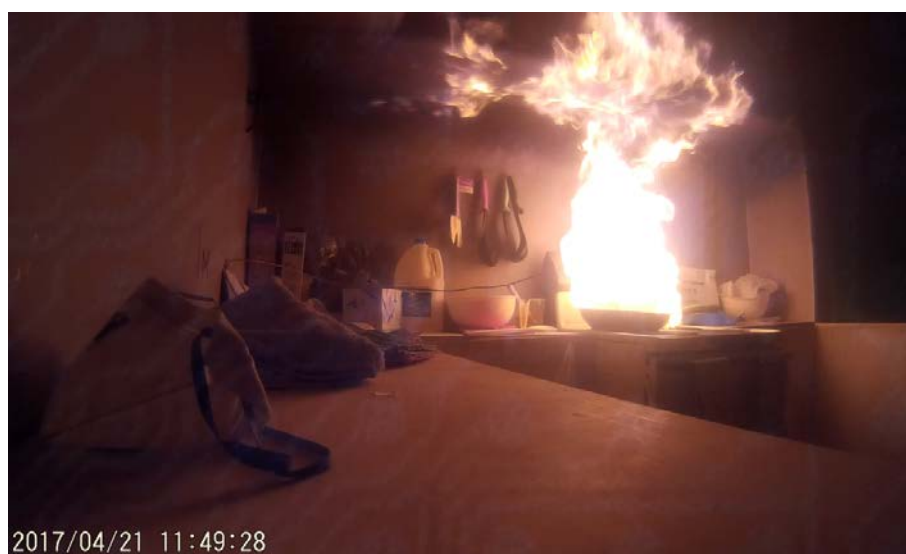
Figure 55 View of the test fire before sprinkler activation

In Test 9, visible smoke begins to issue from the pan at 9 min 30 s from the start of the test. After a further 20 min 18 s, the oil ignited at a pan temperature of 376.2°C (T37). The elevated flames impinged on the overhead cupboards (Figure 55). The fire consumed a number of items in the vicinity of the flames, but did not spread laterally (Figure 56). The last flames were extinguished at approximately 4 min 27 s after ignition.

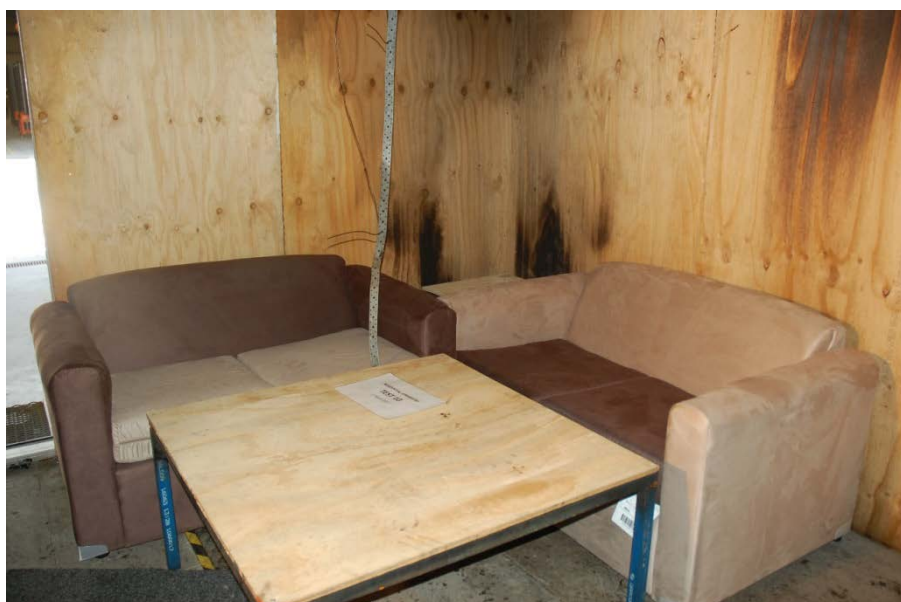
Figure 59 Photo showing the test arrangement for Test 10

In this test, the ignition crib was located in the NW corner of the Lounge room under a stylised plywood side table, which was placed in the corner between two ‘real’ two-seater sofas. The arrangement is pictured in Figure 59 and detailed in Figure 60. In this test, the external doors were closed and the Bedroom 1 door was open. The fuel under the crib was a 1:2 mixture of heptane and water.

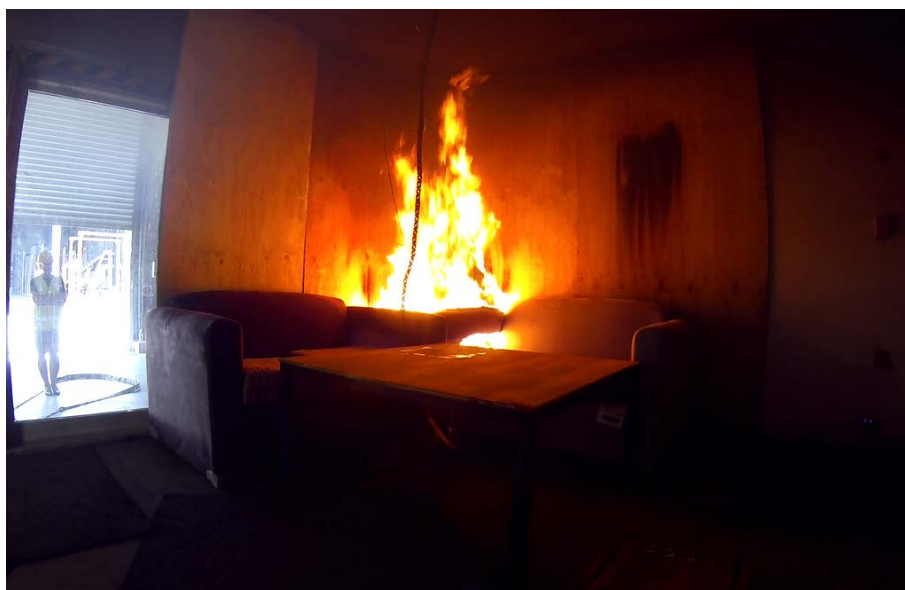
Figure 61 View of the test fire before sprinkler activation

In Test 10, the peak flame height was approximately 2.4 metres or ceiling height (Figure 61). The fire spread to both sofas. The two arm rests were consumed as well as the seat cushion of the northern sofa (Figure 62).

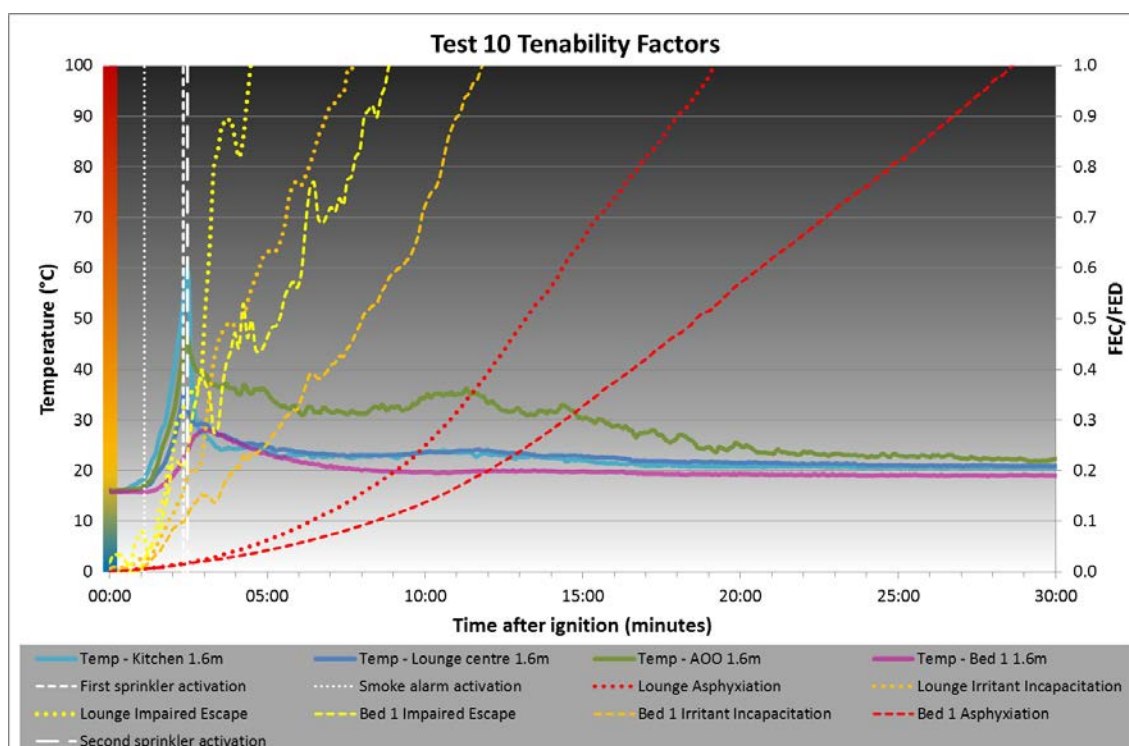
Figure 65 Chart showing timing of activations and tenability factors for Test 10

In Bedroom 1, $FEC_{esc} > 0.3$ was reached at 2 min 46 s and $FEC_{esc} > 1$ was reached at 8 min 52 s. $FEC_{inc} > 0.3$ was reached at 5 min 41 s, with $FEC_{inc} 1$ exceeded after 12 min 3 s. The cumulative asphyxiant gas concentrations rose to $FED_{asp} > 0.3$ in 14 min 42 s, and exceeded $FED_{asp} 1$ after 28 min 44 s.

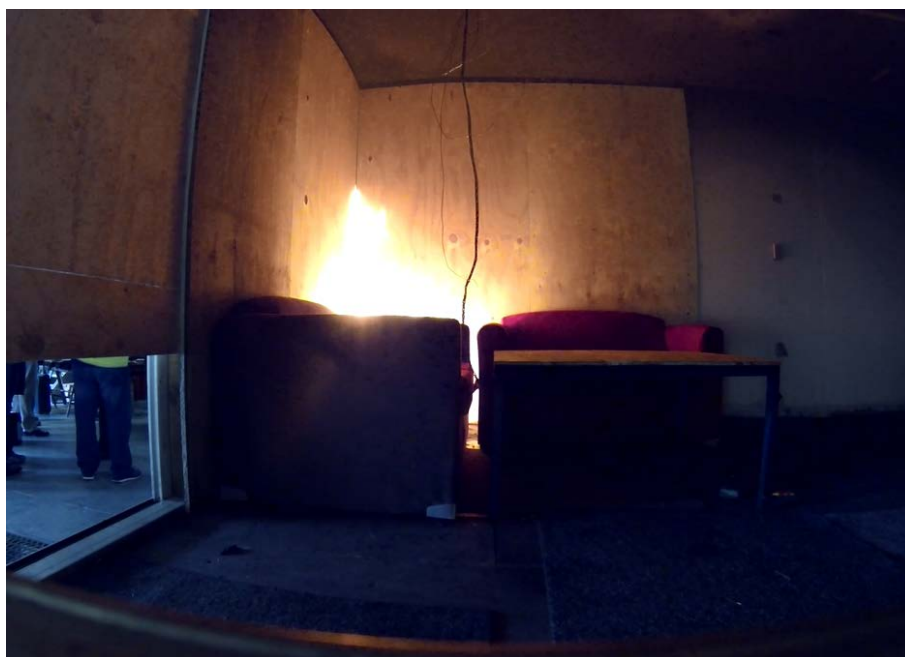
Figure 68 View of the test fire before sprinkler activation

In Test 11, the peak flame height was approximately 1.5 metres (Figure 68). The fire spread to both sofas. The two arm rests were consumed as well as one seat cushion from each sofa (Figure 69).

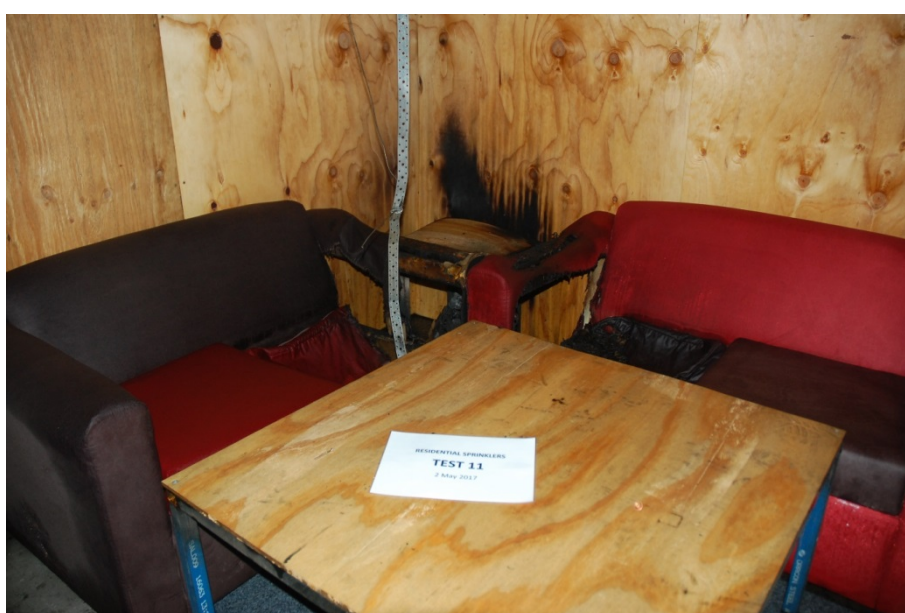
Figure 69 View of the test furnishings at the end of Test 11

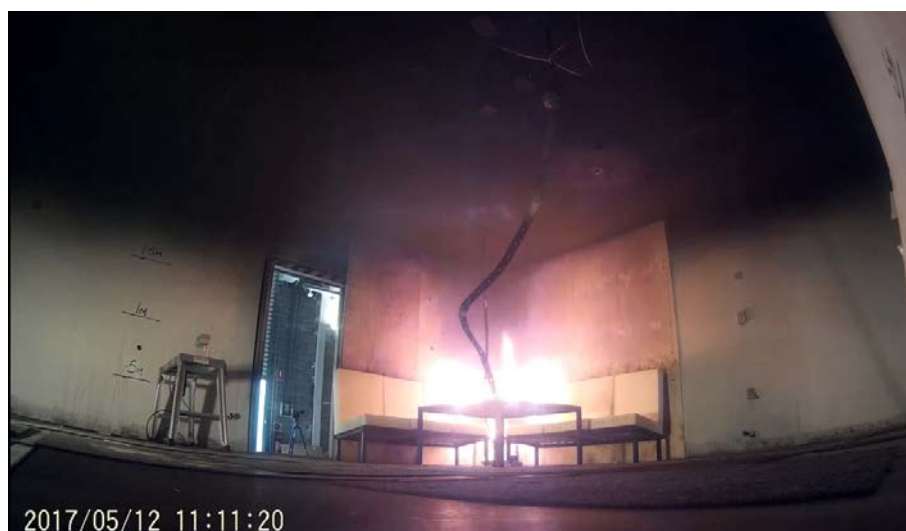
Figure 74 View of the test fire before sprinkler activation

In Test 12, the peak flame height was approximately 1.5 metres (Figure 74). The fire spread to both sofas, consuming most of the foam cushions by test end (Figure 75).

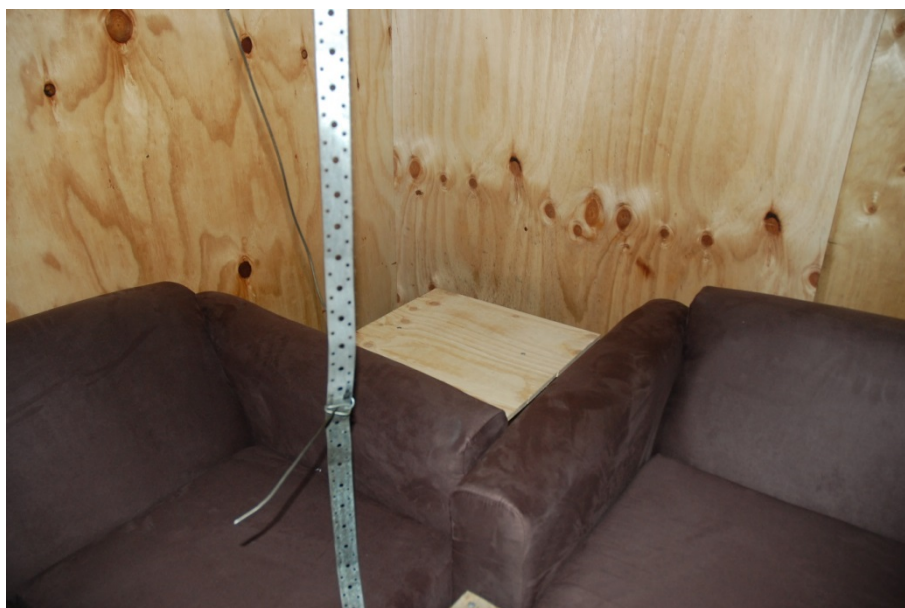
Figure 78 Photo showing the test arrangement for Test 13

arrangement is pictured in Figure 78 and detailed in Figure 79. In this test, the external doors were closed and the Bedroom 1 door was open. The fuel under the crib was a 1:2 mixture of heptane and water.

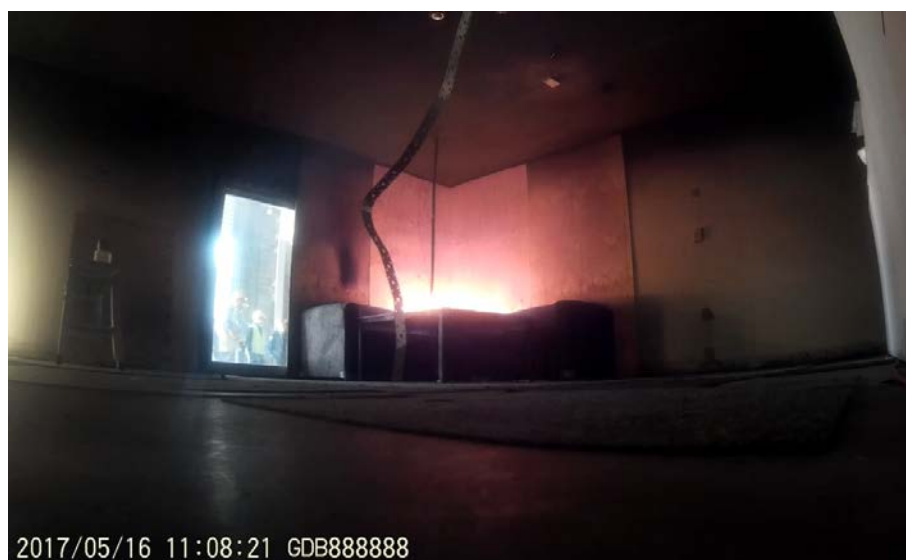
Figure 80 View of the test fire before sprinkler activation

In Test 13, the peak flame height was approximately 1.5 metres (Figure 80). The fire spread mainly to the western sofa, consuming the side of the arm rest and most of one seat cushion (Figure 81).

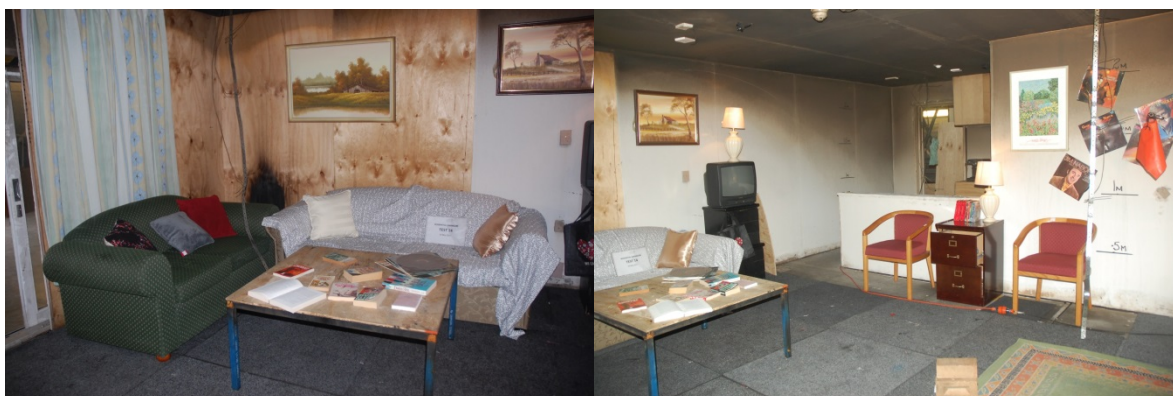
Figure 84 Photo showing the test arrangement for Test 13

In this test, the ignition crib was located in the NW corner of the Lounge room under a stylised plywood side table, which was placed in the corner between two 'real' two-seater sofas. The entire living space is furnished with additional furniture and décor. The arrangement is pictured in Figure 84 and detailed in Figure 85. In this test, the external doors were open and the Bedroom 1 door was open. The fuel under the crib was a 1:2 mixture of heptane and water.

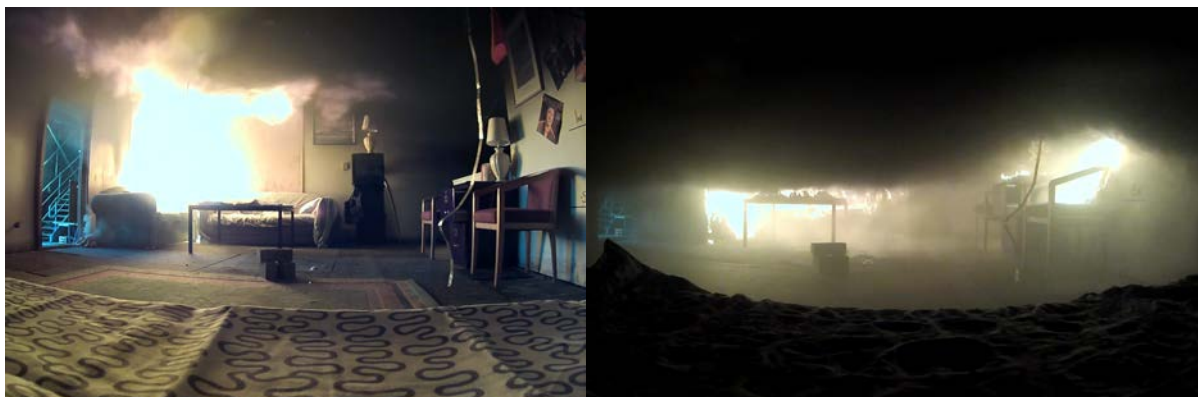
Figure 86 Views of the developing test fire. Note the height of the smoke layer.

In Test 14, the peak flame height was approximately 2.4 metres or ceiling height (Figure 86). The fire spread to full room involvement (Figure 87).
